DEPARTMENT OF NATURAL RESOURCES
DIVISION OF OIL, GAS AND MINING

May 8, 2002

RE: Site Inspections: International Uranium; Hecla Shaft, La Sal-Snowball, Pandora, and Redd Block IV Projects; M/037/043, M/037/026, M/037/012, M/037/046; San Juan County, Utah

Date of Inspection: May 1, 2002
Time of Inspection: about 1:00 to 3:00 p.m.
Conditions: Mostly clear, 50's, windy
Participants: Doug Jensen and Paul Baker, DOGM

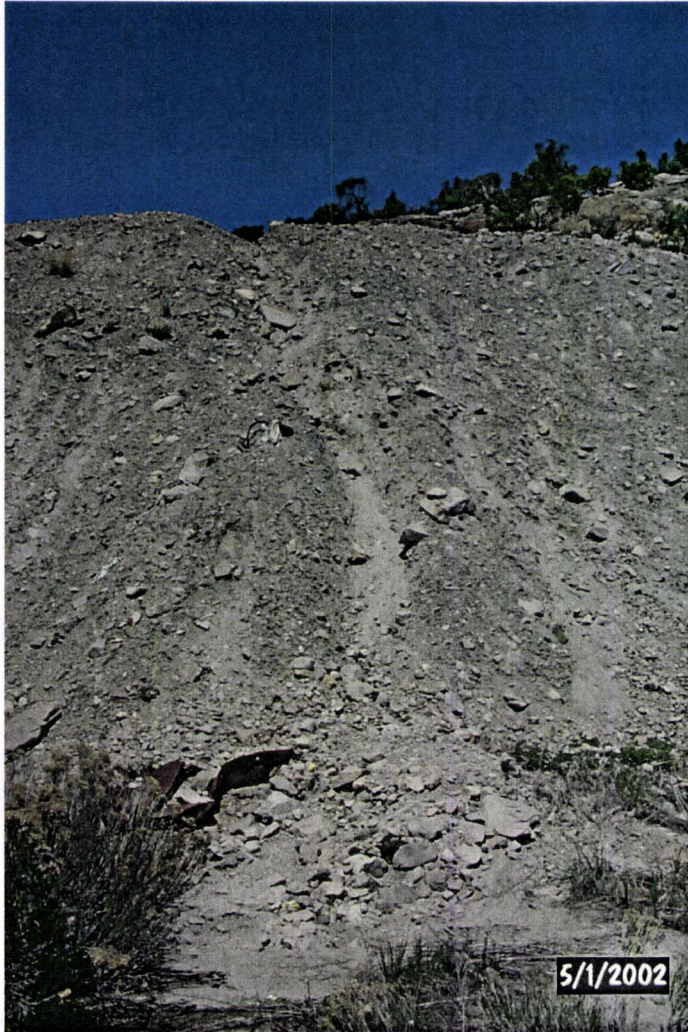
Permit M/037/026 includes both the La Sal and Snowball sites and the Beaver Shaft. At the Snowball site, there has been some erosion from the waste piles (Photo 1), and it appears some of this material has gotten into the drainage (Photo 2). Photo 3 shows some buildings at the Snowball Mine.

Photo 1. Waste pile at the Snowball Mine. Note the erosion.
